Victaulic® FireLock™ IGS™ Installation-Ready™ Style V9 Sprinkler Coupling Limited Hardware Affected by Non-Conformance

WHAT PRODUCT IS AFFECTED?

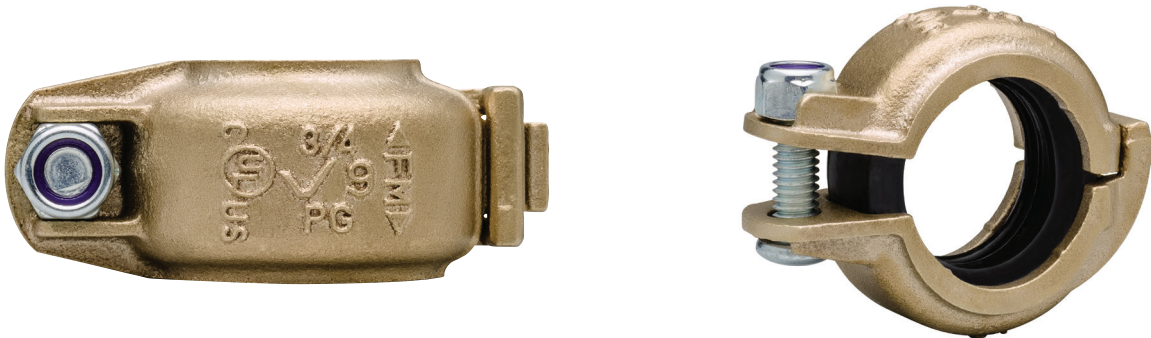
The Style V9 Sprinkler Coupling is secured on one side using a single cap screw and locking nut while the other side is hinged. In couplings with affected cap screws, if the cap screw breaks, the coupling will separate and release the coupling and connected sprinkler from the system piping and result in water discharge from the system outlet. Sprinklers installed using the Style V9 coupling will still perform as intended in response to fire.

Style V9 Sprinkler Couplings manufactured before May 2020 or after October 2021 are not affected by the above non-conformance. Please contact Victaulic if you have questions or believe affected products may be installed in your facility.
